BB BROWN & GAMMONS

CASTOR REDUCTION KIT - FOR MGB, GT & V8 1962-1981

PART No: AHH6195CASTOR

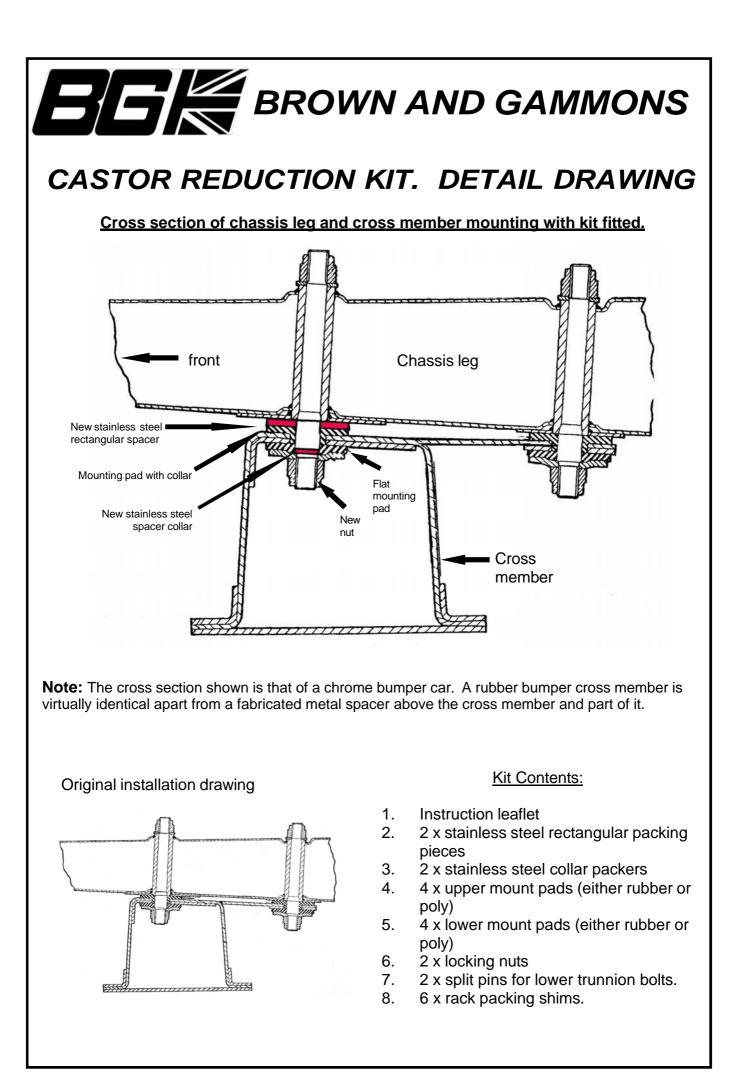
The MGB front crossmember is mounted onto the chassis legs where four high tensile steel studs are positively located on taper seats into the leg. The lower plain portion of the stud is designed to provide a fixed length of location for the crossmember mounts. See picture for detail of the original fitted.

The method of reducing the castor angle is to provide a steel packing on the <u>front</u> two mount studs in order to rotate the crossmember towards the front of the vehicle. Since the steel packing has utilised some of the length of the plain portion of the stud a steel collar has to be fitted which in effect extends the plain stud length back to its original length. Without this the crossmember rubber pad mounts would be compressed too much thereby ruining the mounts and the ride quality and of course giving a variable castor angle. New slightly shallower high tensile nuts are provided to account for the reduction of useable thread length.
